OZARKS WATER WATCH

The Upper White River Basin

Summarizing 2018 Water Quality in the Upper White River Basin

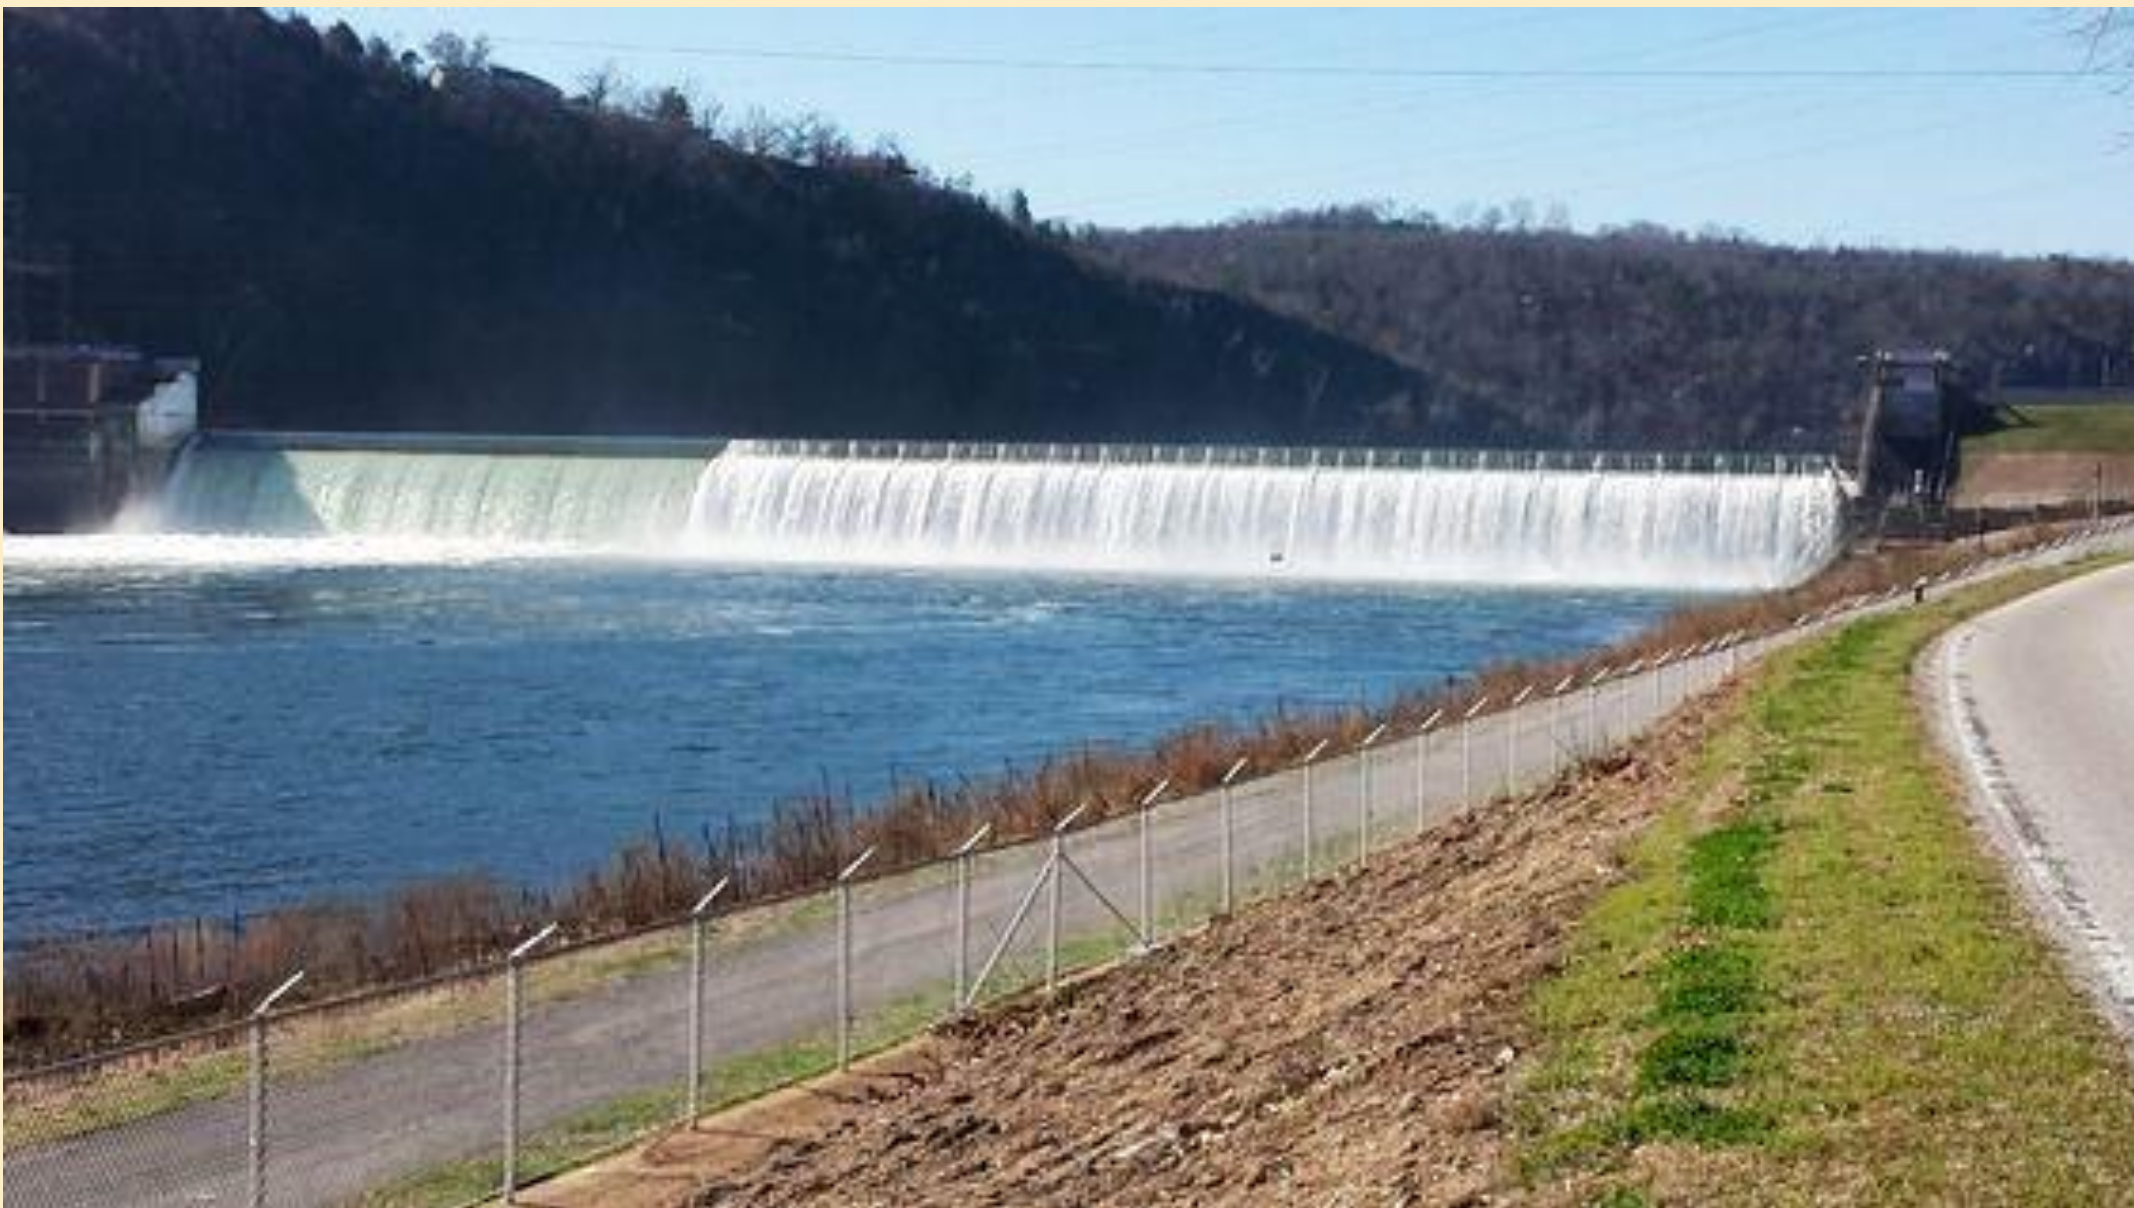
POWERSITE DAM

- ✘ Powersite dam completed in 1913
- ✘ Formed Lake Taneycomo (Taney County, MO)
- ✘ Engineers: 100 year lifespan
- ✘ Warm water fishery and tourist destination
- ✘ Table Rock dam 1959
- ✘ Cold water fishery
- ✘ Sediment / aquatic vegetation a problem
